Surveyor: Zaw La
 Date Visited: 13.10.2016
 Time Visited: 16:00 to 16:30

| No | Item | Condition | Description and Photos |

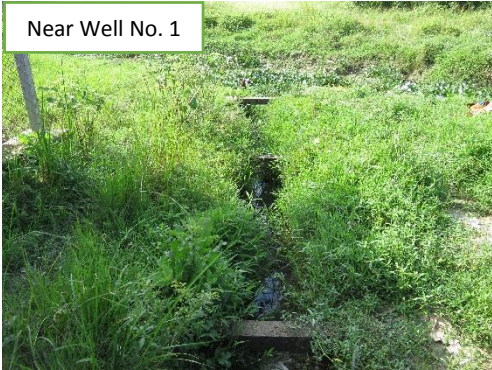
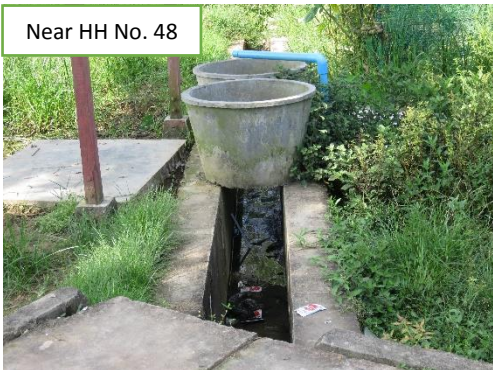
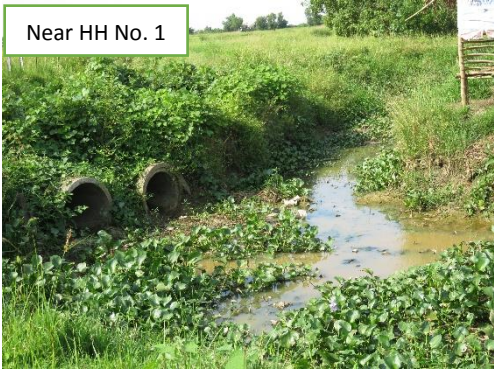
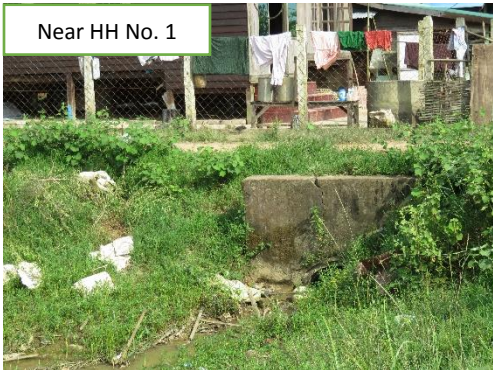
| No | Item | Condition | Description and Photos |
|---|---|---|---|
| | (2). <u>Drainage</u> | Improved <input type="checkbox"/> Same <input checked="" type="checkbox"/> * Worse <input type="checkbox"/> <i>*as last week</i> | <u>Description</u> There is some amount of water in the drainage canals due to the rain yesterday and some places of stream seem to be blocking at the moment. The stream along the drainage canal may need to be rehabilitated in order to improve the water-flow along the stream. <u>Photos</u> <div style="display: flex; flex-wrap: wrap;"> <div style="width: 50%; text-align: center;"> <p>Near Well No. 1</p> </div> <div style="width: 50%; text-align: center;"> <p>Near HH No. 48</p> </div> <div style="width: 50%; text-align: center;"> <p>Near HH No. 1</p> </div> <div style="width: 50%; text-align: center;"> <p>Near HH No. 1</p> </div> </div> |

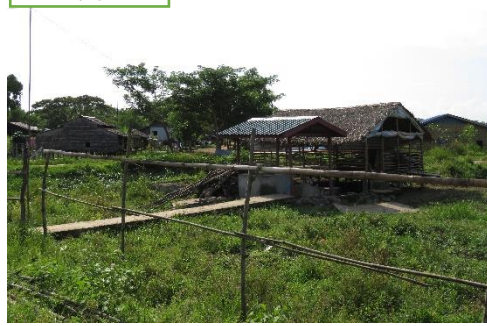
Garbage pit

| <p>(4). Garbage Condition</p> | <p>Improved <input type="checkbox"/></p> <p>Same <input checked="" type="checkbox"/>*</p> <p>Worse <input type="checkbox"/></p> | <p><u>Description</u></p> <ul style="list-style-type: none"> - People do not want to use garbage pit again. - They do not like people to take washing clothes and showering near the well and therefore garbage pit was demolished and water storage tank has been constructed instead of it. -Trash from all houses will be collected by garbage truck biweekly until starting of the community fund. -There was a small seasonal vegetable planting field at the backside of Third Row. Now the season is over and there will be a small plantation field in next season. |

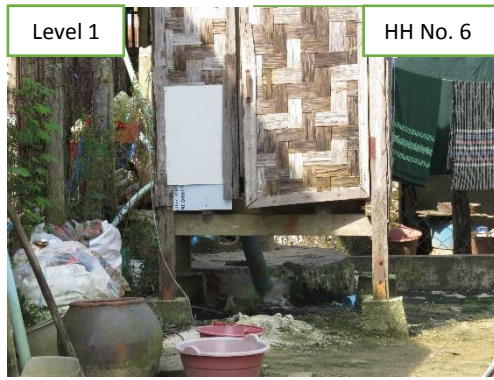
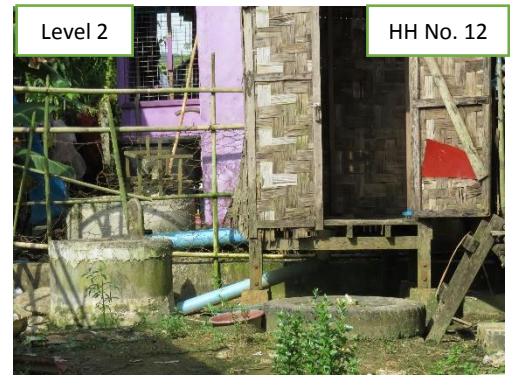
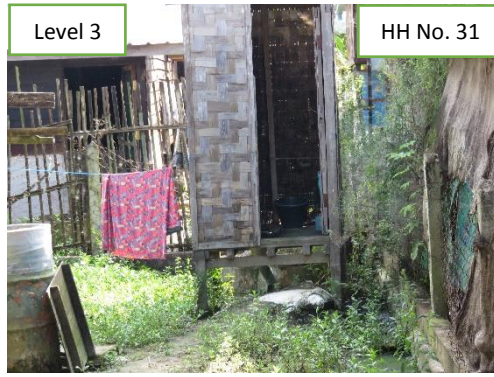
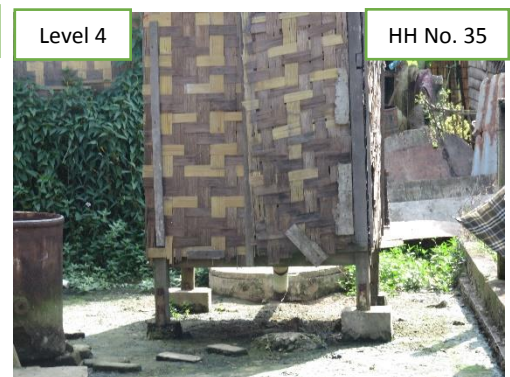
-All of the fly proof toilets are used by people.
 -Almost all of the fly proof toilets made by wood or bamboo have been lifted up as shown in pictures below and are convenient to use. Some concrete toilets are still needed to be renovated. According to discussion with community people, they would like to repair the concrete toilets by themselves and requested for financial support. JET had already paid for it.

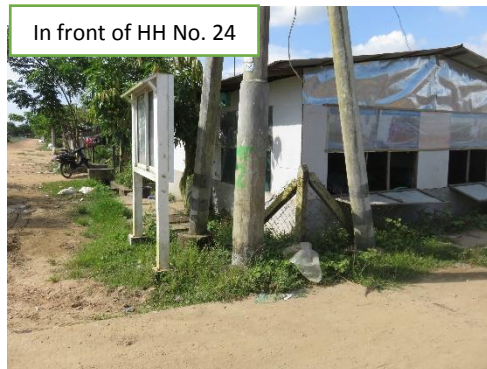
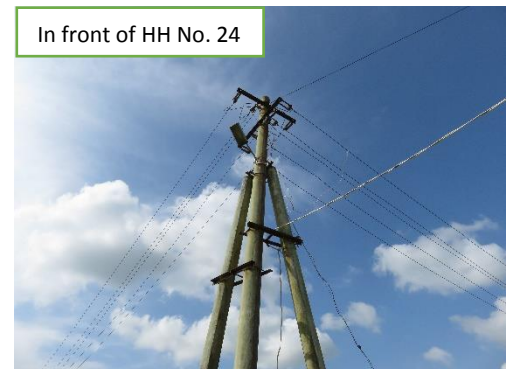
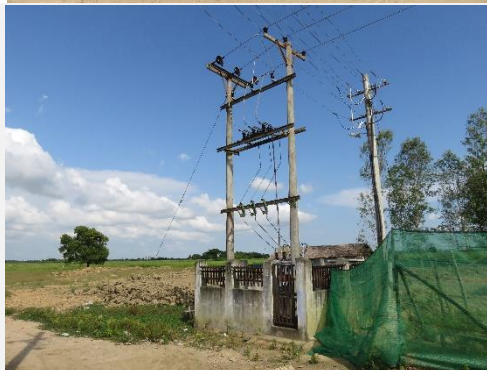
Photos

-Electricity comes regularly.
-Electric poles and transformer are being supported with a good foundation.
-There was a hole at an electric pole which was hit by a truck car but the electric pole was renovated.

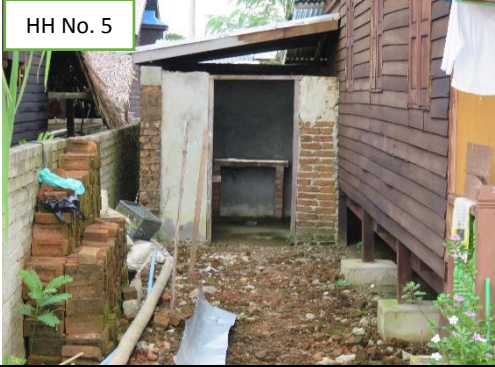
| No | Item | Condition | Description and Photos | | | | | | | | | | | | | | | | | |
|---|---|--|---|---|---|--|---|---|---|---|---|---|---|---|---|---|---|---|---|---|
| 2 | House Construction | No. of houses not completed (2) | <p><u>Description</u> -HH No.5, the construction for kitchen, toilet and water tank seems to be stopped again.</p>

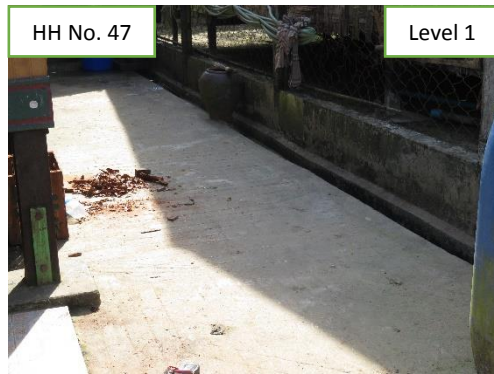
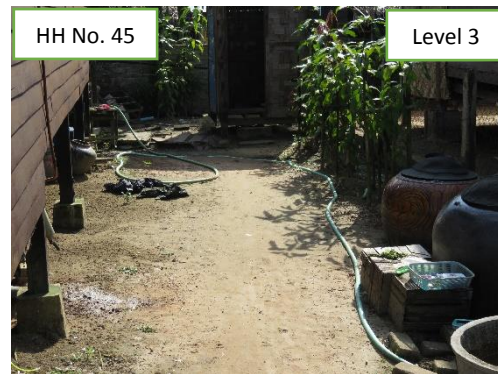
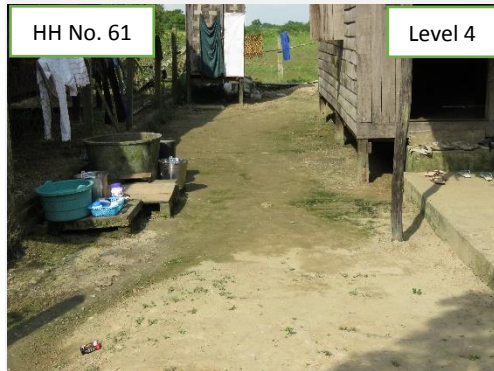
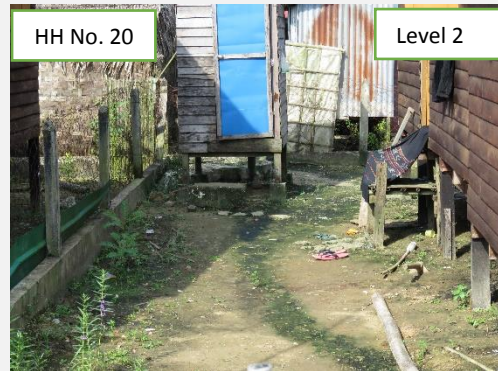
Photos

| | | | | | | | | | | | | | | | | |
| 3 | Living Status of PAPs (Sold house, renting, etc.) | <p><u>Description</u></p> <p>(1) House ownership (1)-1 No. of house that are owned by PAPs (44) (1)-2 No. of house that were sold (24)</p> <p>(2) Living condition (2)-1 No. of houses where PAPs live (36) (2)-2 No. of houses where original PAPs do not live (28) (2)-3 No. of houses where nobody lives (4)</p> | <p>Location Map: See ANNEX.2</p> | | | | | | | | | | | | | | | | | |
| 4 | Other issue | | <p>(1). Drainage condition for rain water in their compounds</p> <p><u>Description</u></p>

<p><Evaluation Criteria></p> <p>Level 1 -No mud and no standing water with their own drainage system in their compound</p> <p>Level 2 -No mud and no standing water in their compound</p> <p>Level 3 - Some or little mud and standing water in their compound</p> <p>Level 4 -A lot of mud and standing water in their compound</p> | Condition | No. of HHs | | This week condition | Previous week condition | Level 1 | 63 | 63 | Level 2 | 5 | 5 | Level 3 | 0 | 0 | Level 4 | 0 | 0 |
| Condition | No. of HHs | | | | | | | | | | | | | | | | | | | |
| | This week condition | Previous week condition | | | | | | | | | | | | | | | | | | |
| Level 1 | 63 | 63 | | | | | | | | | | | | | | | | | | |
| Level 2 | 5 | 5 | | | | | | | | | | | | | | | | | | |
| Level 3 | 0 | 0 | | | | | | | | | | | | | | | | | | |
| Level 4 | 0 | 0 | | | | | | | | | | | | | | | | | | |
