Surveyor Zaw La  
 Date visited 21 Jun 2019  
 Time visited 10:30 am

No	Item	Condition	Narrative Description and Photos
1	(1.1) Water Supply System	Improved <input type="checkbox"/> Same <input checked="" type="checkbox"/> * Worse <input type="checkbox"/> *as last week	<p><b><u>Narrative Description</u></b></p> <p>Water distribution system has been supporting ninety household of the zone B resettled families. The new well was drilled and installed the pipe line and its necessary instruments because the underground water of the previous well includes iron hydroxide and yellowish mud that clogged in the iron removal tank. The current water condition is quite good and no iron hydroxide and yellowish mud are found.</p> <p><b><u>Photos</u></b></p> <div style="display: flex; flex-wrap: wrap;"> <div style="width: 50%; text-align: center;">

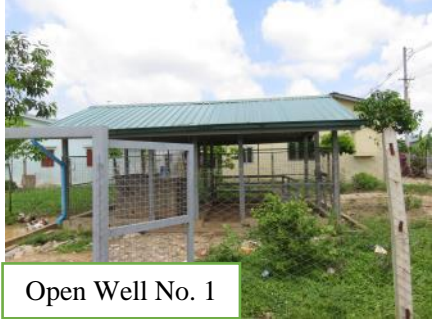
<p>Open Well No. 1</p> </div> <div style="text-align: center;">

No	Item	Condition	Narrative Description and Photos
1	(1.2) Well	Improved <input type="checkbox"/> Same <input checked="" type="checkbox"/> * Worse <input type="checkbox"/> <i>*as last week</i>	<p>– Water from two open-wells is clean enough to use for drinking and living. There are eleven tube wells in the relocation site. Residents use the water basically from the pipeline distribution system so that the frequency of water usage from the tube wells is very low. To sustain the good condition of the tube wells, the leg pumps were kept and covered the PVC pipes with the caps till the residents use.</p>
			<div style="display: flex; justify-content: space-around;"> <div style="text-align: center;">

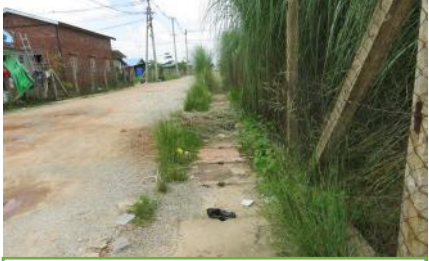
(2) Drainage	Improved <input type="checkbox"/> Same <input checked="" type="checkbox"/> * Worse <input type="checkbox"/> <i>*as last week</i>	<p>– There is a little amount of water in the drainage canals at the moment.</p> <p><b>Photos</b></p> <div style="display: grid; grid-template-columns: 1fr 1fr; gap: 10px;"> <div style="text-align: center;">

<p>The drain at the corner of Main Road A and B</p> </div> <div style="text-align: center;">

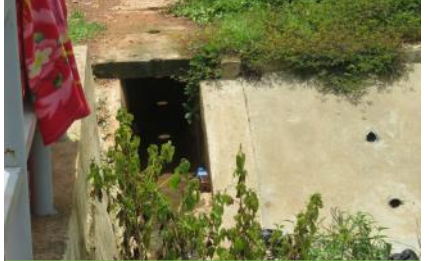
<p>The exit of the drain at the corner of Site village road and 3<sup>rd</sup> street</p> </div> <div style="text-align: center;">

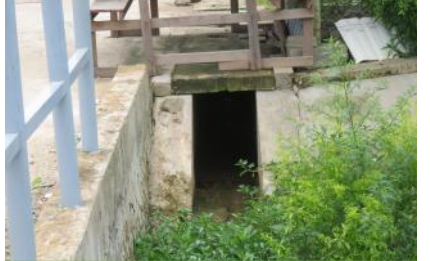
<p>The exit of the drain at the corner of Site village road and Main Road C</p> </div> </div>

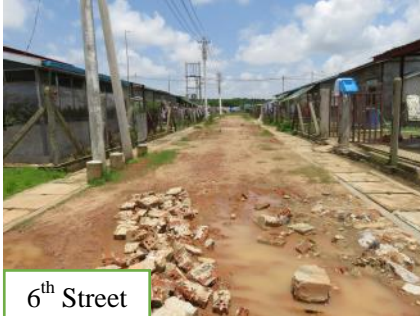
<p>6<sup>th</sup> Street</p>

(3) Road	Improved <input type="checkbox"/> Same <input checked="" type="checkbox"/> * Worse <input type="checkbox"/> <i>*as last week</i>	<p>– All the roads except 6<sup>th</sup> street are still dry and no problem for walking. 6<sup>th</sup> street is being damaged due to passing the heavy trucks that carry the soil to fill near the creek side. Therefore the exits of the drain at the 6<sup>th</sup> street are being blocked with the soil.</p> <p><b>Photos</b></p>

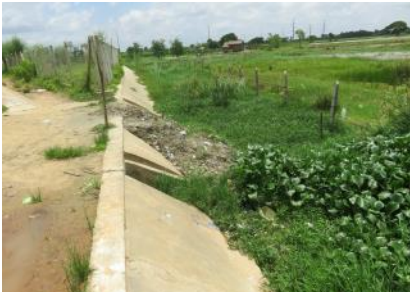
<p>Rubbishes in the creek near 1st street</p>

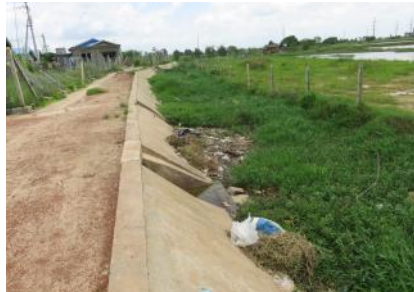
<p>Rubbishes in the creek near 2nd street</p>

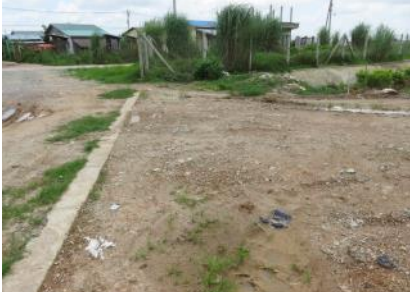
<p>The soil was filled near the creek of Main Road C in March</p>

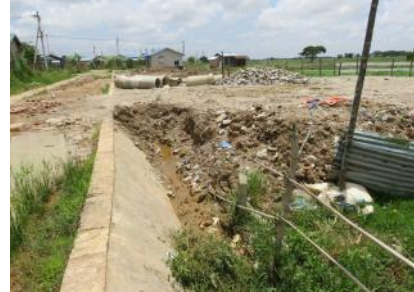
<p>The soil was filled near the creek of 6<sup>th</sup> Street in March</p>

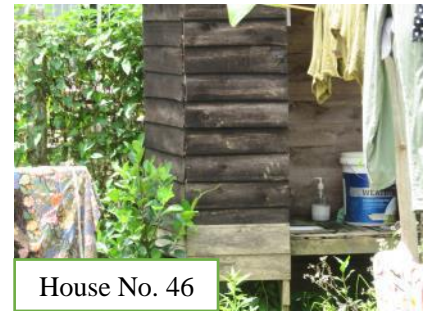
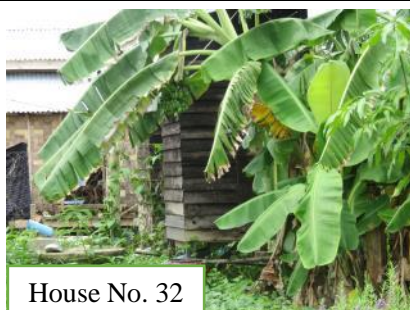
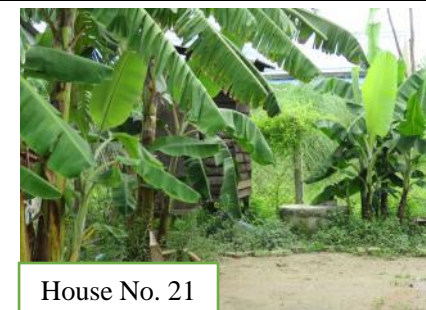
- All of the fly proof toilets are used the residents.
- All of the toilets are repaired by the following procedures;
  - Installation the extra septic tanks beside the original
  - The pipe line system is installed from the extra tank to the ditch to flow the liquid out.

The toilet renovation plan was successfully done and there is no problem at the moment.

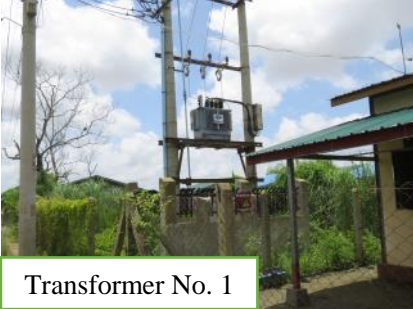
<p>Transformer No. 1</p>

(6) Electricity	Improved <input type="checkbox"/> Same <input checked="" type="checkbox"/> * Worse <input type="checkbox"/> <i>*as last week</i>	<ul style="list-style-type: none"> <li>– Residents get the electricity regularly.</li> <li>– Electric poles and transformer are being supported with the good foundations.</li> <li>– There are some pieces of wood under an electric pole of main road B and it's needed to clean up.</li> </ul> <p><b>Photos</b></p>

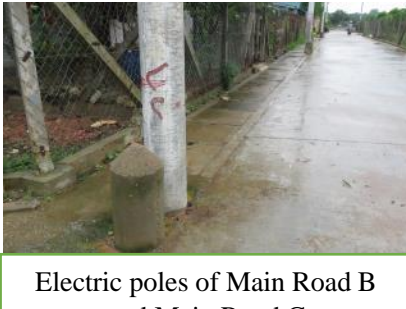
<p>Electric poles of Main Road B and Main Road C</p>
No	Item	Condition	Description and Photos	
2	(1)House Construction	No. of houses which are not completed (4)	<ul style="list-style-type: none"> <li>– In plot No.9 and 10, three houses that are planned to build as the plots are owned by father and son. The second floors of these three houses are needed to be carried on.</li> <li>– Plot No.64, the house construction seems to be stopped.</li> <li>– Plot No. 66, the house construction for the first floor has been finished and the second floor is still needed to be carried on.</li> </ul> <p><b>Photos</b></p>

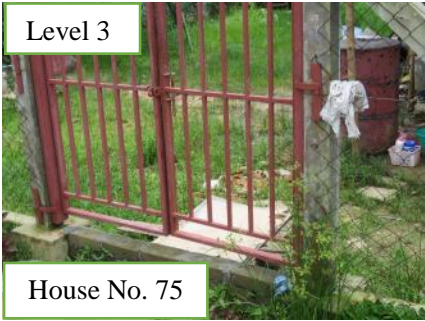
- Some or little mud and standing water in their compound

<p>Level 3</p> <p>House No. 75</p>

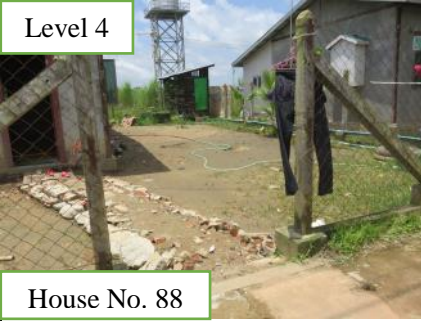
-A lot of mud and standing water in their compound

<p>Level 4</p> <p>House No. 88</p>															
(2) Plantation		<p>- In front of the compounds, the shady trees, fruit trees, flowering plants and vegetables are being planted.</p> <p><u>Description</u></p> <p>- In front of the compounds, the shade trees, fruit trees, flowering plants and vegetables are being planted.</p>
