Surveyor: Zaw La
 Date Visited: 5.7.2016
 Time Visited: 10:30 to 11:45

No	Item	Condition	Description and Photos
1	Condition of -		
	(1). Well	Improved <input type="checkbox"/> Same <input checked="" type="checkbox"/> * Worse <input type="checkbox"/> <i>*as last week</i>	Description & Photos: -See ANNEX.1 - Water from both of two wells is clean and can be used for drinking and living. The amount of water in both wells is also being increased during these days. There are four tube wells in the relocation site. Among them, one of the hand pump needs to be repaired, but people can get water from their own tube-wells, one open-well and the rest of two hand pumps.

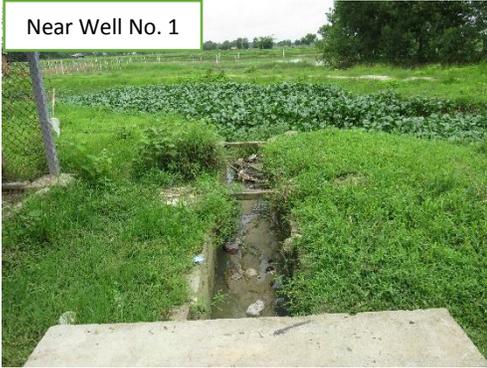
(2). Drainage	Improved <input type="checkbox"/> Same <input checked="" type="checkbox"/> * Worse <input type="checkbox"/> <i>*as last week</i>	<u>Description</u> There is some amount of water in the drainage canals due to the rain yesterday and some places of stream seem to be blocking at the moment. The stream along the drainage canal may need to be rehabilitated in order to improve the water-flow along the stream. <u>Photos</u> <div style="display: flex; flex-wrap: wrap; justify-content: space-around;"> <div style="text-align: center;"> <p>Near Well No. 1</p>

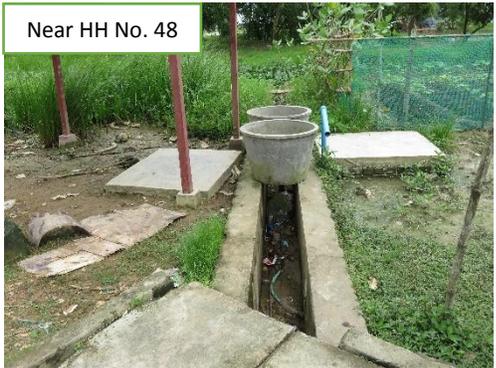
</div> <div style="text-align: center;"> <p>Near HH No. 48</p>

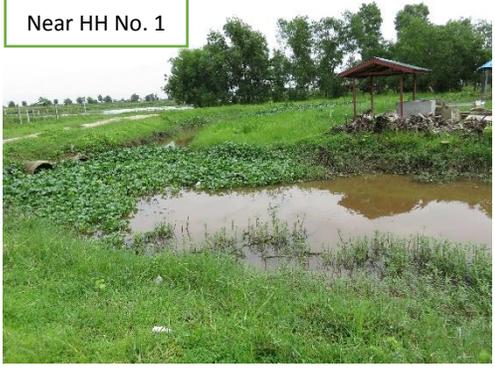
</div> <div style="text-align: center;"> <p>Near HH No. 1</p>

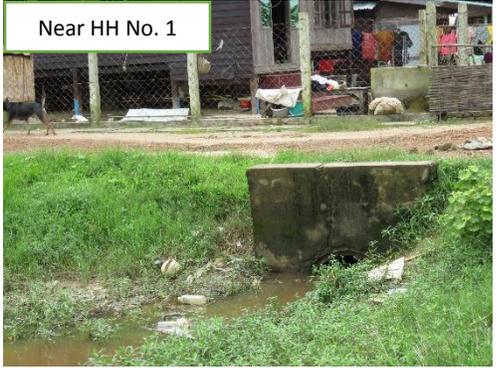
</div> <div style="text-align: center;"> <p>Near HH No. 1</p>

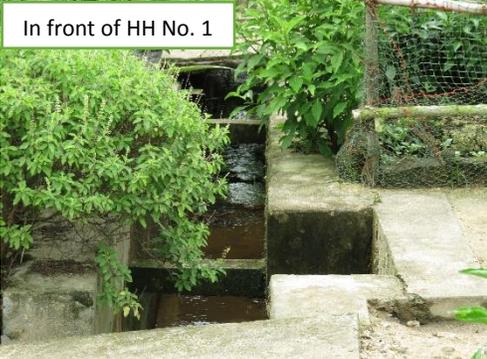
<p>In front of HH No. 1</p>

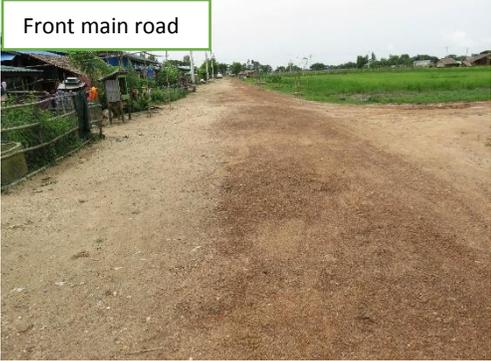
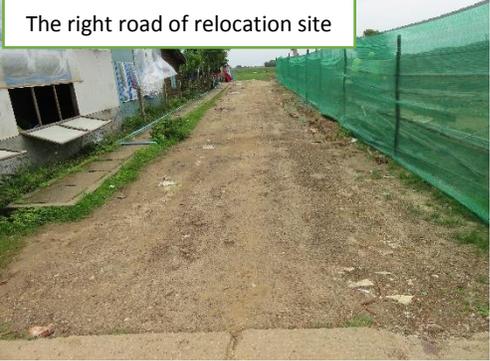
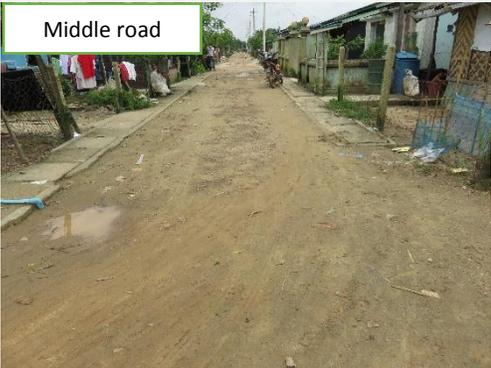
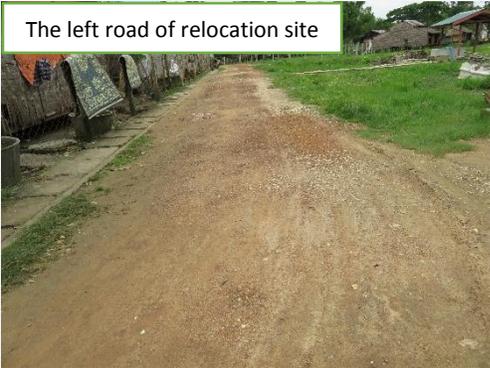
(3). Road	<p>Improved <input checked="" type="checkbox"/>*</p> <p>Same <input type="checkbox"/></p> <p>Worse <input type="checkbox"/></p> <p><i>*as last week</i></p>	<p><u>Description</u></p> <p>-The roads are being dry and no problem for walking.</p> <p><u>Photos</u></p>

<p>Front main road</p>

<p>The right road of relocation site</p>

<p>Middle road</p>

<p>The left road of relocation site</p>

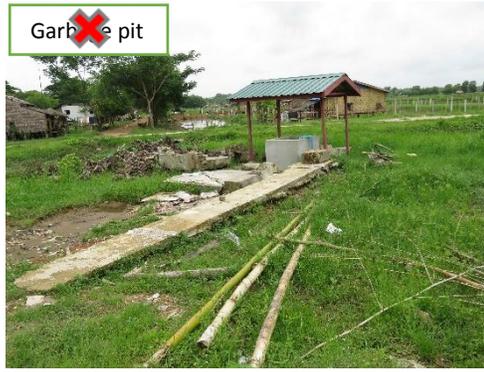
Garbage pit

(4). Garbage Condition	<p>Improved <input type="checkbox"/></p> <p>Same <input checked="" type="checkbox"/>*</p> <p>Worse <input type="checkbox"/></p>	<p><u>Description</u></p>	<p>- People do not want to use garbage pit again.</p> <p>- They do not like people to take washing clothes and showering near the well and therefore garbage pit was demolished and water storage tank has been constructed instead of it.</p> <p>-Trash from all houses will be collected by garbage truck biweekly until starting of the community fund.</p> <p>-There is a small vegetable planting field at the backside of Third Row where there were many trashes before the vegetable plantation was started.</p>

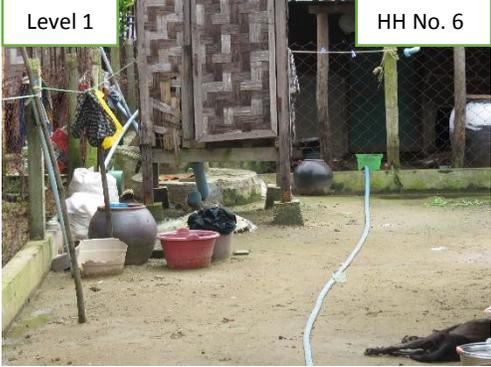
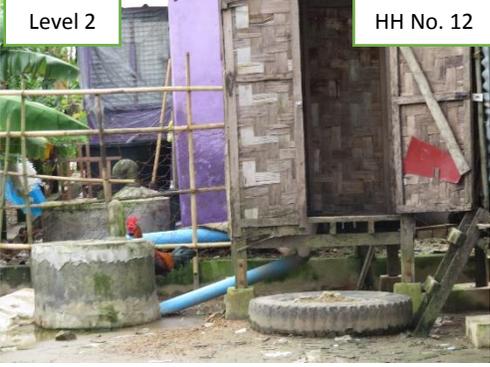
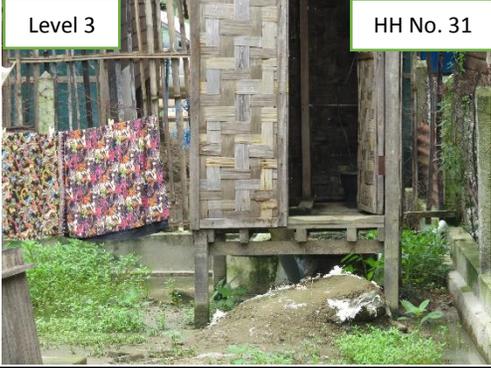
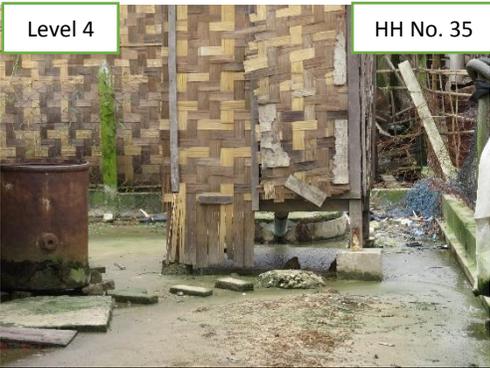
-All of the fly proof toilets are used by people.
 -Almost all of the fly proof toilets made by wood or bamboo have been lifted up as shown in pictures below and are convenient to use. Some concrete toilets are still needed to be renovated. According to discussion with community people, they would like to repair the concrete toilets by themselves and requested for financial support. JET had already paid for it.

<p>-Often toilet unavailable</p> <div style="display: flex; flex-wrap: wrap;"> <div style="width: 50%;"> <p>Level 1 HH No. 6</p>

</div> <div style="width: 50%;"> <p>Level 2 HH No. 12</p>

</div> <div style="width: 50%;"> <p>Level 3 HH No. 31</p>

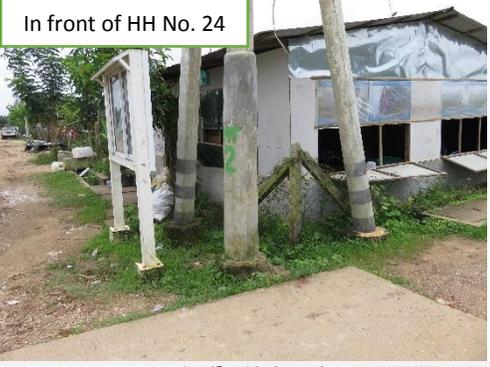
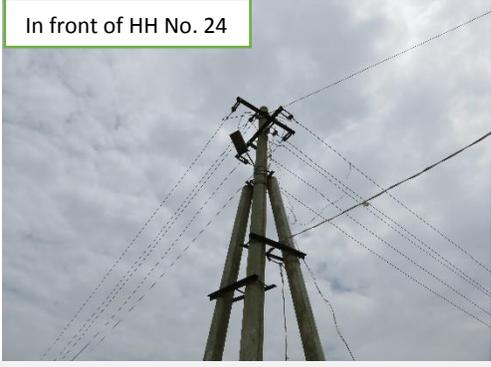
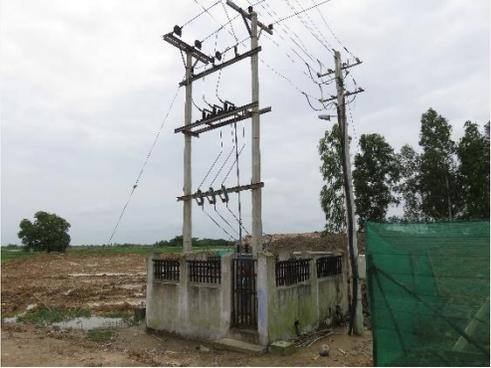
(6).	Electricity	<p>Improved <input checked="" type="checkbox"/>*</p> <p>Same <input type="checkbox"/></p> <p>Worse <input type="checkbox"/></p> <p><i>*as last week</i></p>	<p><u>Description</u></p> <ul style="list-style-type: none"> -Electricity comes regularly. -Electric poles and transformer are being supported with a good foundation. -There was a hole at an electric pole which was hit by a truck car but the electric pole was renovated. <p><u>Photos</u></p> <div style="display: flex; flex-wrap: wrap;"> <div style="width: 50%;"> <p>In front of HH No. 24</p>

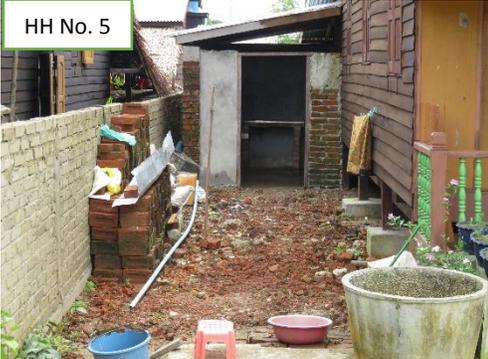
2	House Construction	No. of houses not completed (2)	<p><u>Description</u> -HH No.5, the construction for kitchen, toilet and water tank seems to be stopped again.</p>

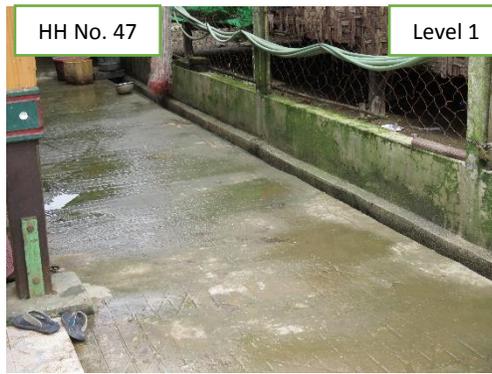
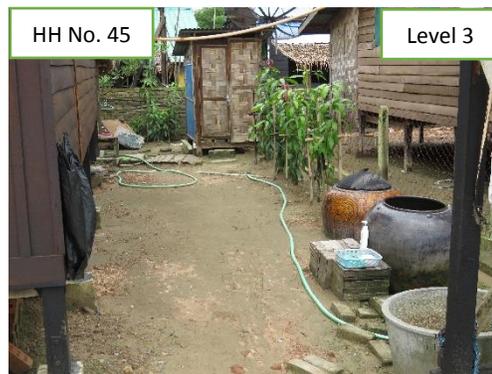
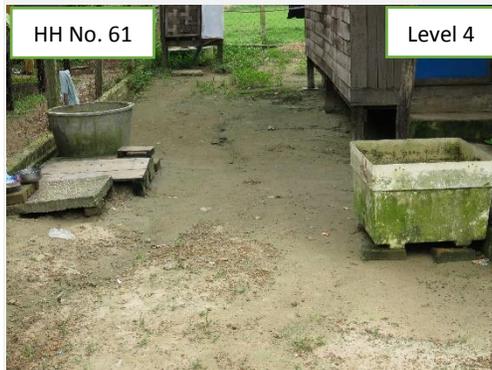
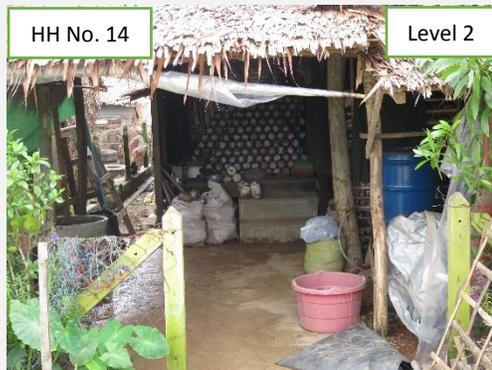
Photos

<p><Evaluation Criteria> Level 1 -No mud and no standing water with their own drainage system in their compound Level 2 -No mud and no standing water in their compound Level 3 - Some or little mud and standing water in their compound Level 4 -A lot of mud and standing water in their compound</p>		Condition	No. of HHs		This week condition	Previous week condition	Level 1	63	63	Level 2	5	5	Level 3	0	0	Level 4	0	0
Condition	No. of HHs																			
	This week condition	Previous week condition																		
Level 1	63	63																		
Level 2	5	5																		
Level 3	0	0																		
Level 4	0	0
