Surveyor: Zaw La
 Date Visited: 26.11.2015
 Time Visited: 15:30 to 16:00

Weather Condition: Sunny
 The last time of heavy raining: - 3 weeks ago

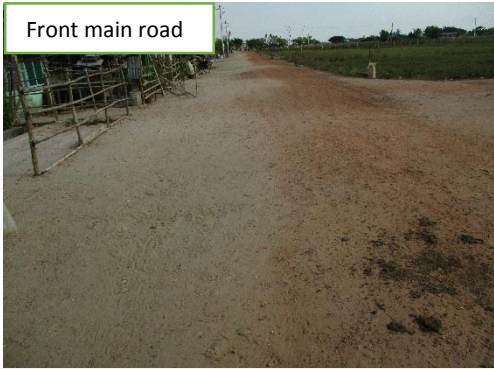
<p>(3). Road</p>	<p>Improved <input checked="" type="checkbox"/>*</p> <p>Same <input type="checkbox"/></p> <p>Worse <input type="checkbox"/></p> <p><i>*as last week</i></p>	<p><u>Description</u></p> <p>-The roads are being dry and no problem for walking.</p> <p><u>Photos</u></p> <div style="display: flex; flex-wrap: wrap;"> <div style="width: 50%; text-align: center;"> <p>Front main road</p>

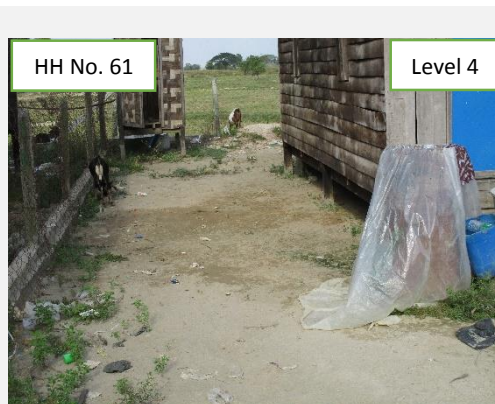
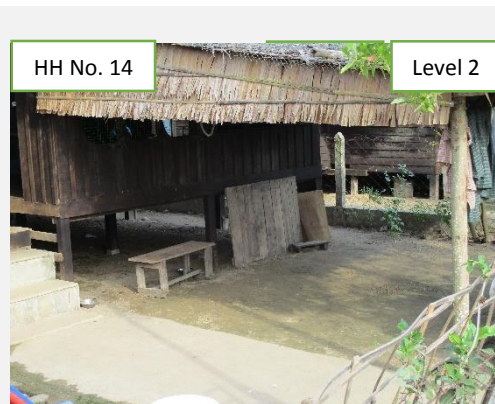
4	Other issue	Description																	
	(1). Drainage condition for rain water in their compounds	<p><u>Description</u> -Rainy season has started. -Some of the compounds are wet.</p>

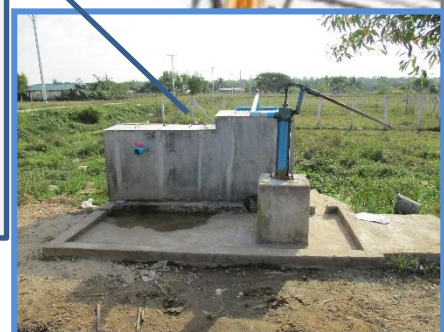
This hand pump is functioned very well. Water is clean and people living nearby are using this hand pump. Moreover water filter tank for removing the smell of iron has been set up beside the hand pump. There is no smell of iron and people enjoy water for drinking and living use.
