Surveyor: Zaw La

Date Visited: 21.9.2015

No	Item	Condition	Description and Photos
1	<b>Condition of -</b>		
	(1). Well	Improved <input type="checkbox"/> Same <input checked="" type="checkbox"/> * Worse <input type="checkbox"/>  <i>*as last week</i>	Description & Photos: -See ANNEX.1 - Although both of the two open wells are dirty, it seems that muddy water under the ground is passing through the crack at the wall of the well. Compared with last week, well no. 1 is gradually clean this week and used by surrounding people again. In terms of avoiding the muddy groundwater passing to the well, both open wells need to be renovated again in summer. The buffers of some hand pumps need to be changed, but people get water from their own well or rain water currently.

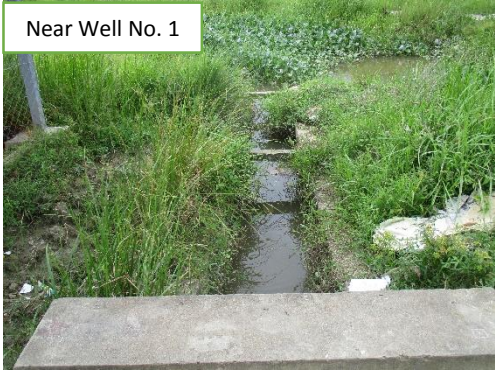
<p>Near Well No. 1</p> </div> <div style="width: 50%; text-align: center;">

(2). <u>Drainage</u>	Improved <input type="checkbox"/> Same <input checked="" type="checkbox"/> * Worse <input type="checkbox"/> <i>*as last week</i>	<u>Description</u> -Water level in the drainage canals is higher than last week because it was a heavy rain in last two days ago. The stream along the drainage canal may need to be rehabilitated in order to improve the water-flow in coming summer period.  <u>Photos</u>  <div style="display: flex; flex-wrap: wrap;"> <div style="width: 50%; text-align: center;">

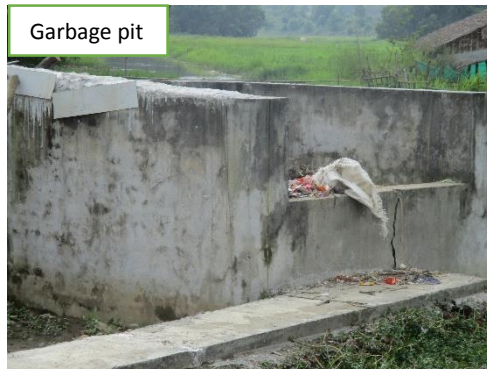
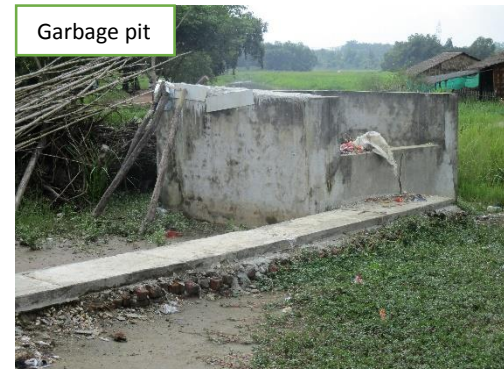
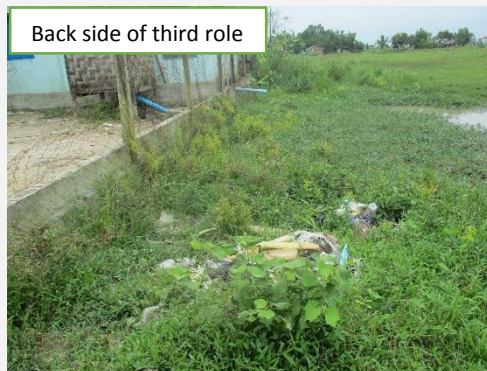
(3). Road	<p>Improved <input type="checkbox"/></p> <p>Same <input checked="" type="checkbox"/>*</p> <p>Worse <input type="checkbox"/></p> <p><i>*as last week</i></p>	<p><u>Description</u></p> <p>-The roads are almost being dry and no problem for walking.</p> <p><u>Photos</u></p>	       
(4). Garbage Condition	<p>Improved <input type="checkbox"/></p> <p>Same <input checked="" type="checkbox"/>*</p> <p>Worse <input type="checkbox"/></p>	<p><u>Description</u></p> <p>-Garbage pit is being used by people.</p> <p>-Garbage pit was cleaned and a new access way to garbage pit had been constructed.</p> <p>-There is no problem for smelling from the garbage pit so far.</p> <p>-People throw garbage at the backside of Third Row and it needs to be collected.</p>

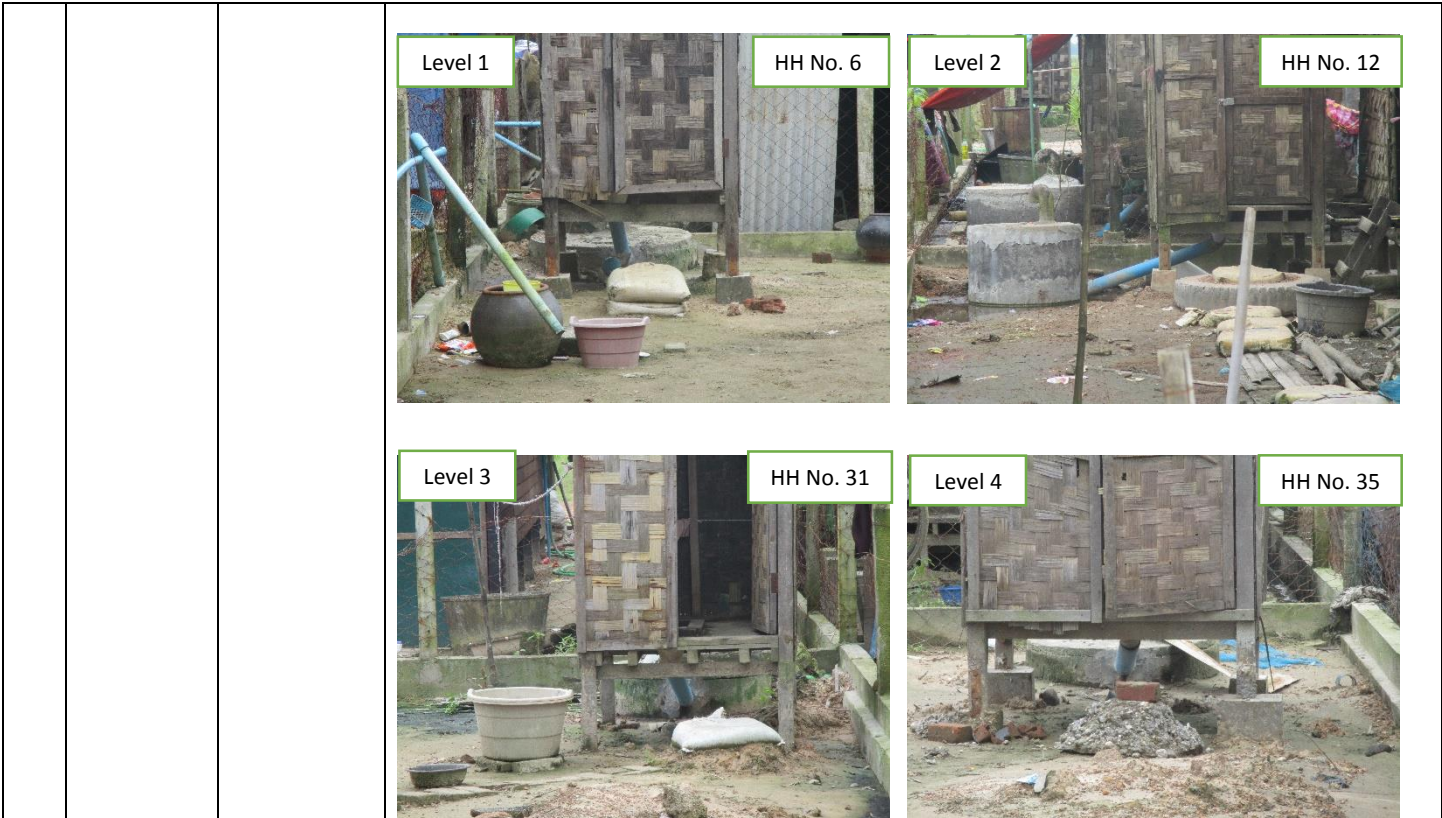
-All of fly proof toilets are used by people.  
-Almost all of fly proof toilets made by wood or bamboo have been lifted up as shown in below pictures. Some concrete toilets are still needed to be renovated too as their floors are low and will be inconvenient to use sometimes when there is heavy rain and groundwater level is raised.

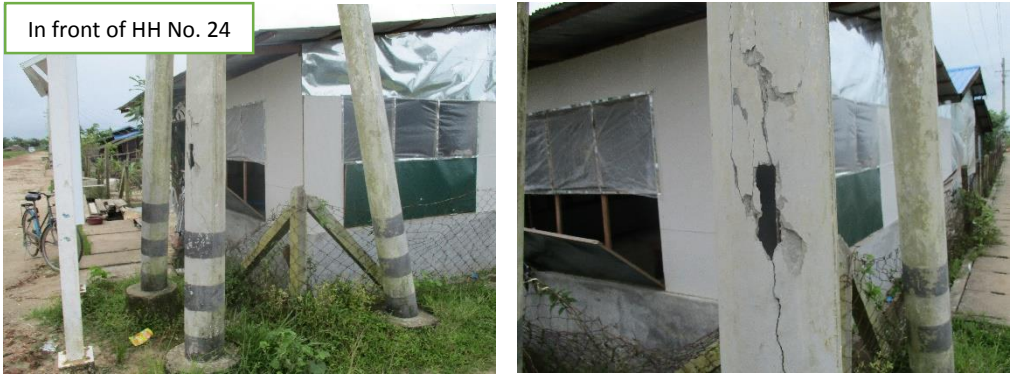
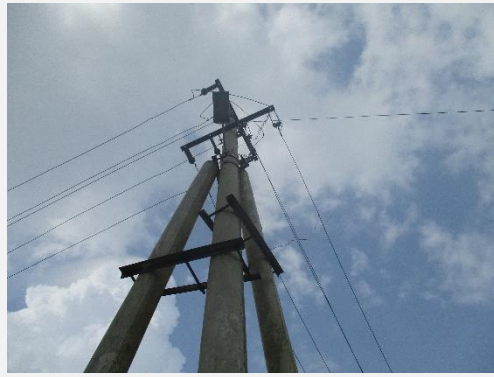
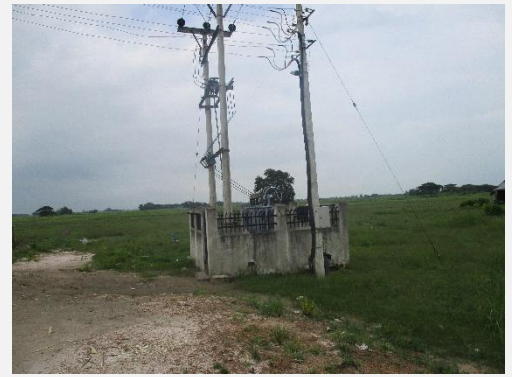
- Electricity comes regularly.
- Electric poles and transformer are being supported with a good foundation.
- But, there is a hole at an electric pole which was hit by a truck car. The electric pole needs to be renovated.

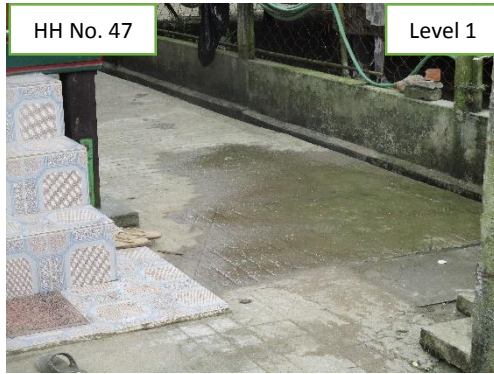
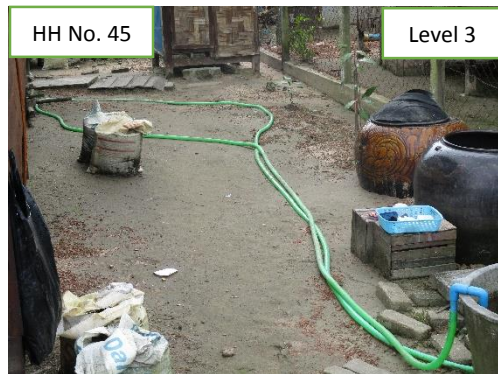
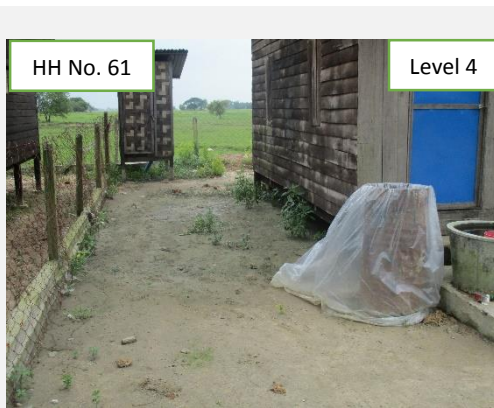
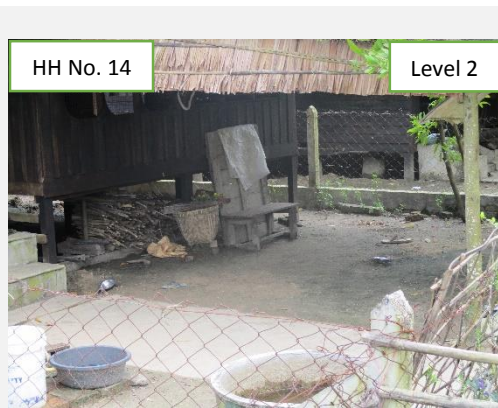
(1). Drainage condition for rain water in their compounds	<p><u>Description</u> -Rainy season has started. -Some of the compounds are wet.</p>

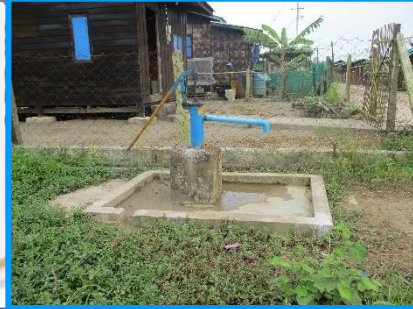
1

Water is clean and people nearby are using it for drinking and living use . A pulley wheel, bucket and a rope have been set up but the rope seems to be thin and it is better to be changed with thick one for the better use.

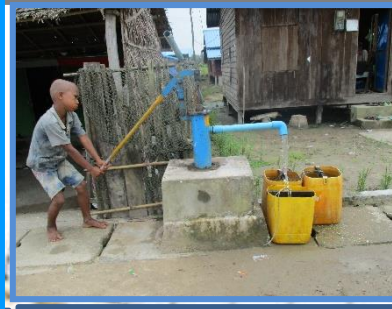
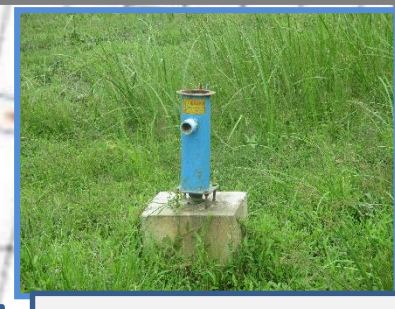
2

This well cannot be used as water is dirty. A pulley wheel, bucket and a rope have been set up but the rope seems to be thin and it is better to be changed with a thick one for the better use.

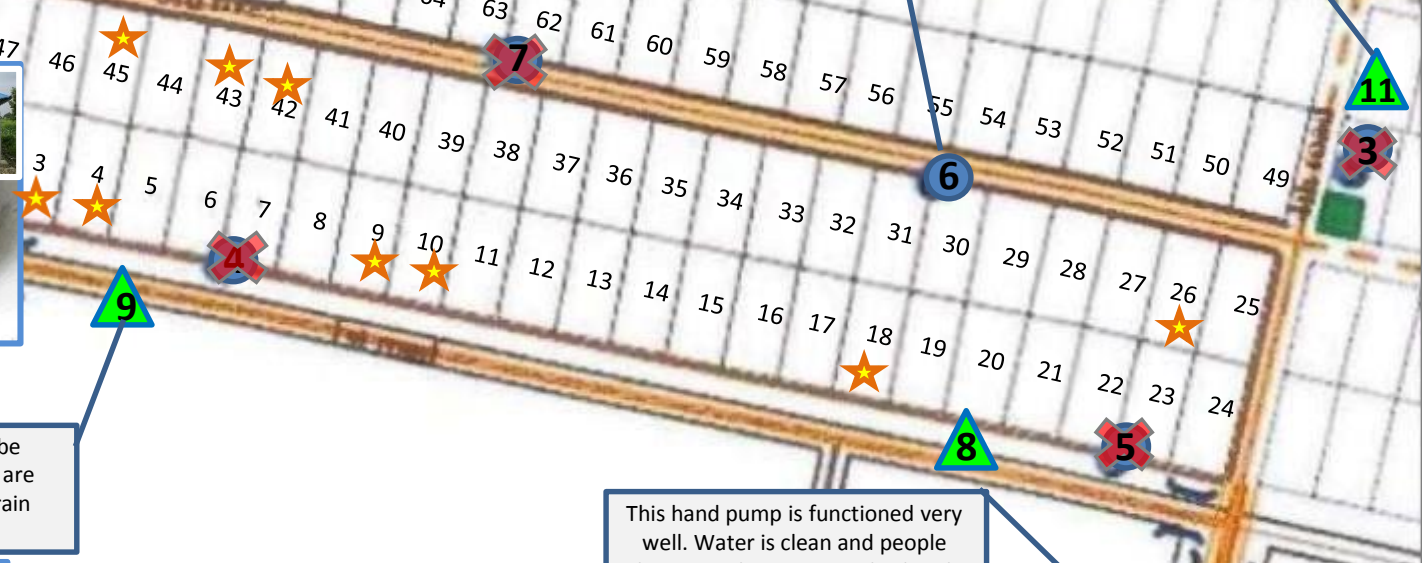
As the buffer has been changed with the new one and the hand pump is functioned very well now. Water is also clean and people living nearby use it for drinking and living use again.

This hand pump is functioned very well. Water is clean and people nearby are using this hand pump for drinking and living use.

Hand pump isn't functioned.

The buffer of the hand pump needs to be change. Therefore, people living nearby are using water from their owned pump or rain water at the moment.

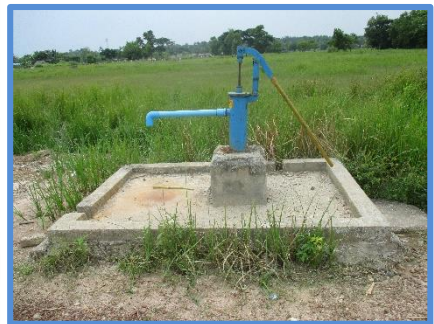
This hand pump is functioned very well. Water is clean and people living nearby are using this hand pump. Moreover water filter tank for remove the smell of iron has been set up beside the hand pump. There is no smell of iron and people enjoy water for drinking and living use.
