Weekly Field Report

No. 15

Surveyor: Sithu Nyein

Date Visited: 02.12.2014

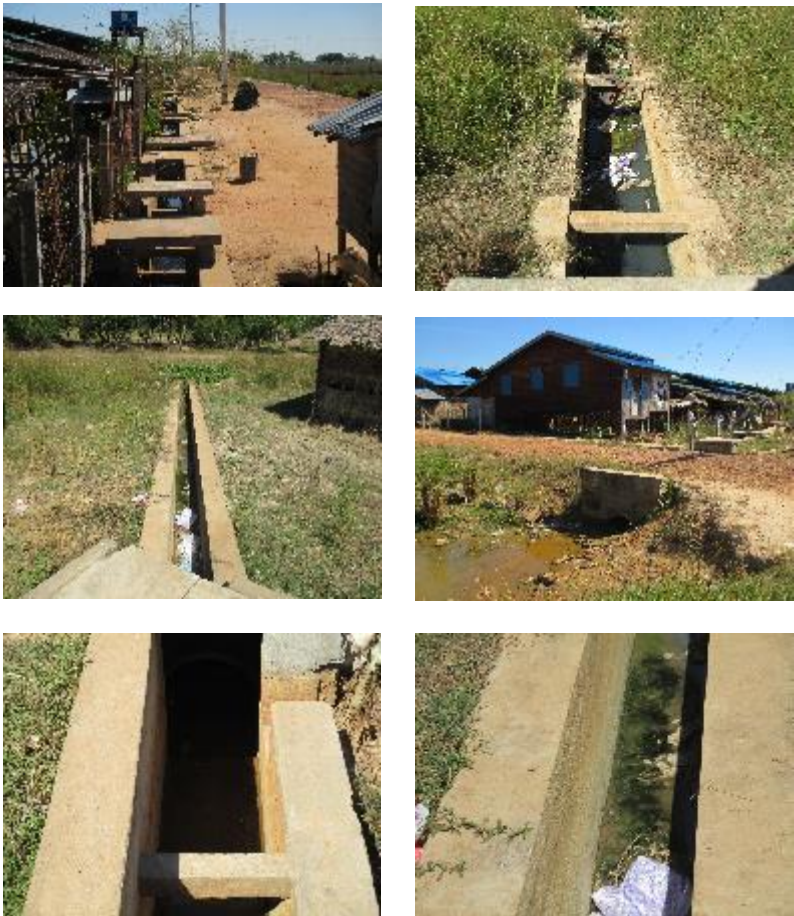
No	Item	Condition	Description and Photos
1	Condition of -		
	(1). Well	Improved <input type="checkbox"/> Same <input checked="" type="checkbox"/> * Worse <input type="checkbox"/> <i>*as last week</i>	Description & Photos: -See ANNEX.1 -Hand Pump of Well No. 6, 9 and 11 are needed to repair.
	(2). Drainage	Improved <input checked="" type="checkbox"/> Same <input type="checkbox"/> Worse <input type="checkbox"/>	<u>Description</u> -Water level in the drainage canal is near to the bottom. <u>Photos</u>

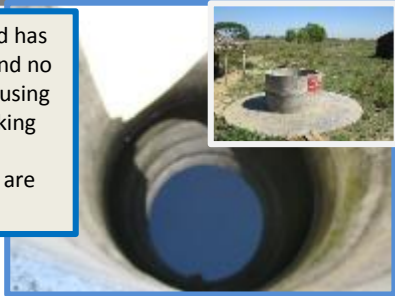
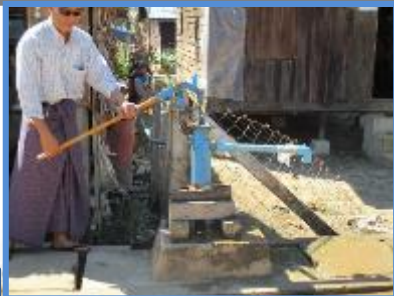
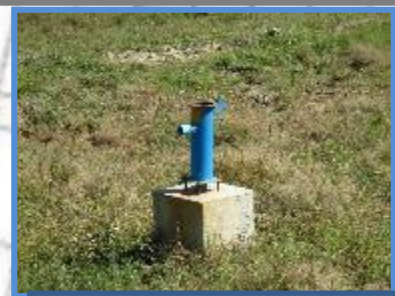
Water is clean and has no sand, no clay and no smell. People are using this well for cooking and washing. Sometimes they are drinking

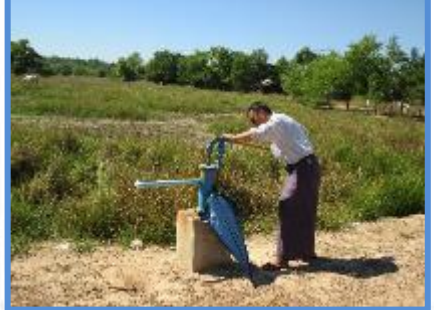
Hand pump isn't functioned very well. The washer needs to be repaired. The color of water likes red. People who live nearby aren't using this well. People buy water from private well of HH No.4 for washing, cooking and drinking. They have to pay 100 Ks per day of use. They take water to their houses with movable pipe.
